Applies To: **1994-00 Accord** – ALL with M/T
1992-01 Prelude – ALL with M/T

August 7, 2001

Fifth Gear Grinds During Upshift

(Replaces 95-057, dated October 17, 2000)

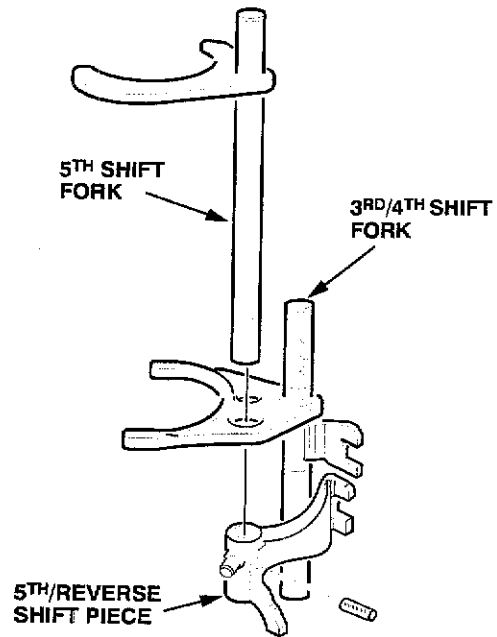
Misalignment from the 5th shift fork.

- Replace the 5th shift fork.
