Applies To: 1997 Prelude – with A/T thru VIN JHMBB6...VC012298

April 21, 1997

## MIL Stays On After Starting / DTCs P1768 and P1773

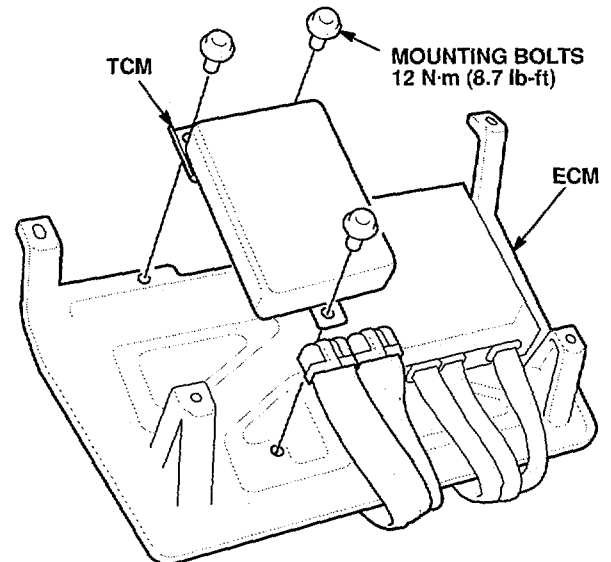
Electrical spikes from the ignition switch affect the Transmission Control Module (TCM).

1. Remove the passenger's side door sill molding.
2. Pull the passenger's side carpet back to expose the ECM cover.
3. Remove the ECM cover mounting nuts, then turn the ECM cover over.
4. Remove the TCM by disconnecting the two connectors and removing the three mounting bolts.

5. Install the new TCM in the reverse order of removal, and reinstall all removed parts.
6. Record the customer's radio station presets, and the radio anti-theft code.
7. Pull the BACK-UP (10 A) fuse from the under-hood fuse box for 10 seconds to reset the ECM and the TCM.
8. Enter the radio anti-theft code and the customer's radio station presets. Reset the clock.
