Applies To: 1997 Prelude – Type SH

April 21, 1997

ATTS Heat Shield Rattle or Buzzing

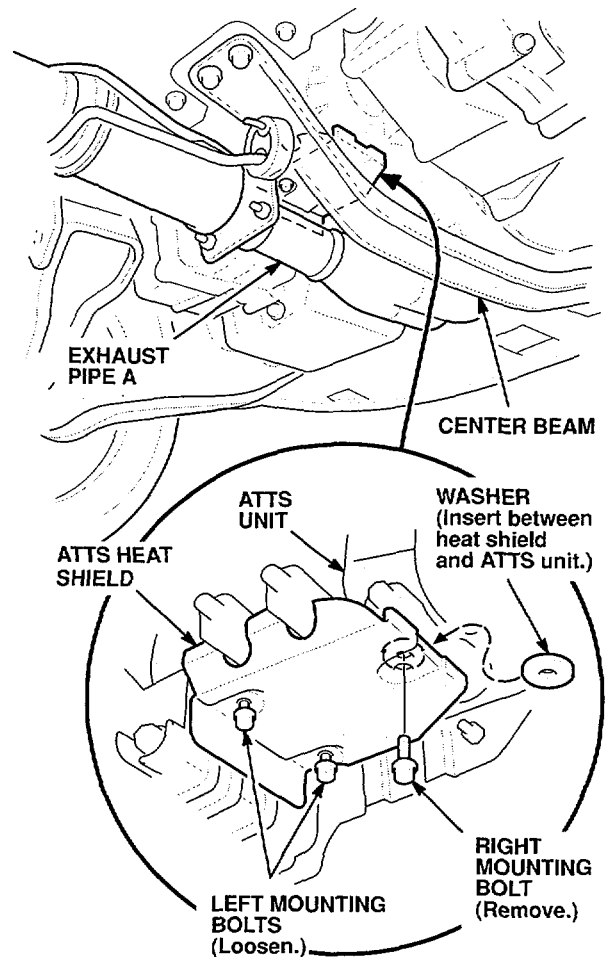
A rattle or buzzing noise from under the vehicle when accelerating from 3500 to 5200 rpm.

Insufficient clearance between the Active Torque Transfer System (ATTS) unit and the heat shield.

1. Raise the vehicle on a hoist.
2. Loosen the two left mounting bolts, and remove the right mounting bolt on the ATTS unit heat shield.

3. Insert the washer between the ATTS unit and the heat shield, then reinstall the right mounting bolt.
4. Torque all three mounting bolts to 9.8 N-m (7 lb-ft).
