Applies To: 1997-99 Prelude – ALL

Clunking Noise From the Trunk Area (Supersedes 97-048, dated June 9, 1997)

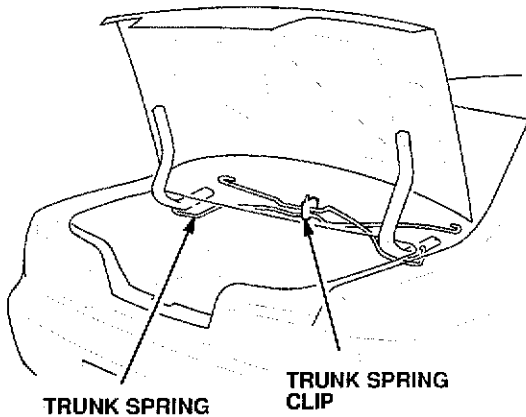
The trunk spring clip is out of its mounting holes.

Replace the trunk spring clip.

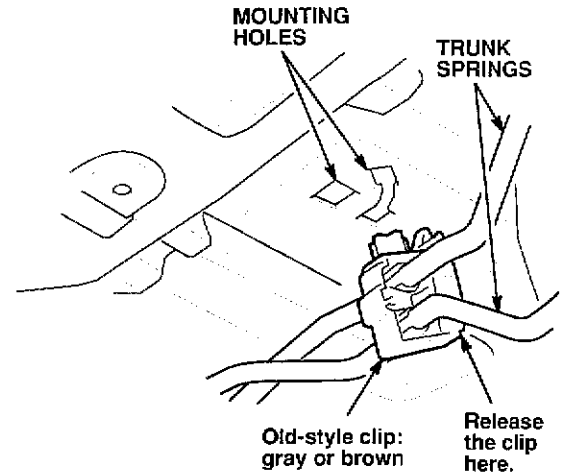
1. Check to see if the trunk spring clip is out of its mounting holes.
