***Restoration Options for Bowker Creek:  
Demonstration Segment Downstream of Haultain Street***

**Mine Bieller, Katia Gauvin, Gagan Leekha & Regan Walker  
Environmental Technology Program, Camosun College**

**July 4, 2002**

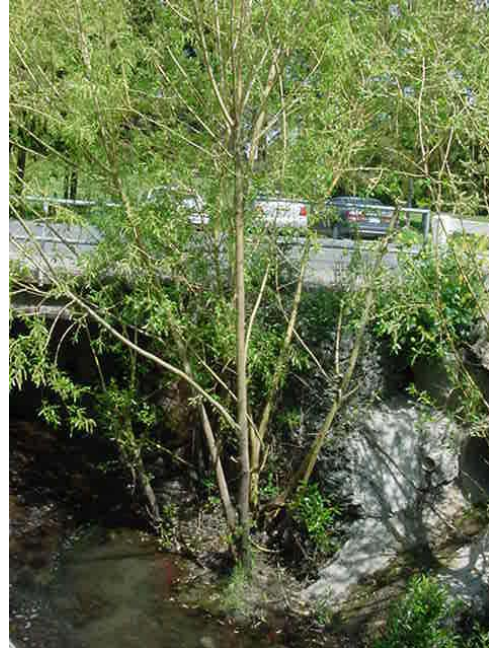
Figure 2: Golden Willow in Stream

Networks of Golden Willow roots encroach into the active channel (Figure 2), collecting debris and impeding the drainage of storm water. These networks can displace the natural channel bed and its dependent invertebrate populations. During storm events and high flows, there is potential for root networks to be pulled from the bed and block culverts. Willows are also responsible for significant removal of stream water during periods of low flow due to their high rates of transpiration. Finally, Golden Willow out-competes native willows as well as other native species (Crowther, 2000).

- i) Remove the Golden Willow by cutting the tree, leaving a stump half of a metre to one metre in height. Make vertical cuts in the top of the freshly cut stump. This will leave the tree vulnerable to pathogens. Continue to make vertical cuts every two months for about six months, or until the tree dies from stress methods. The root systems are left intact to ensure bank stability while newly planted native vegetation becomes established (Dept. of Land & Water Conservation, 2002).

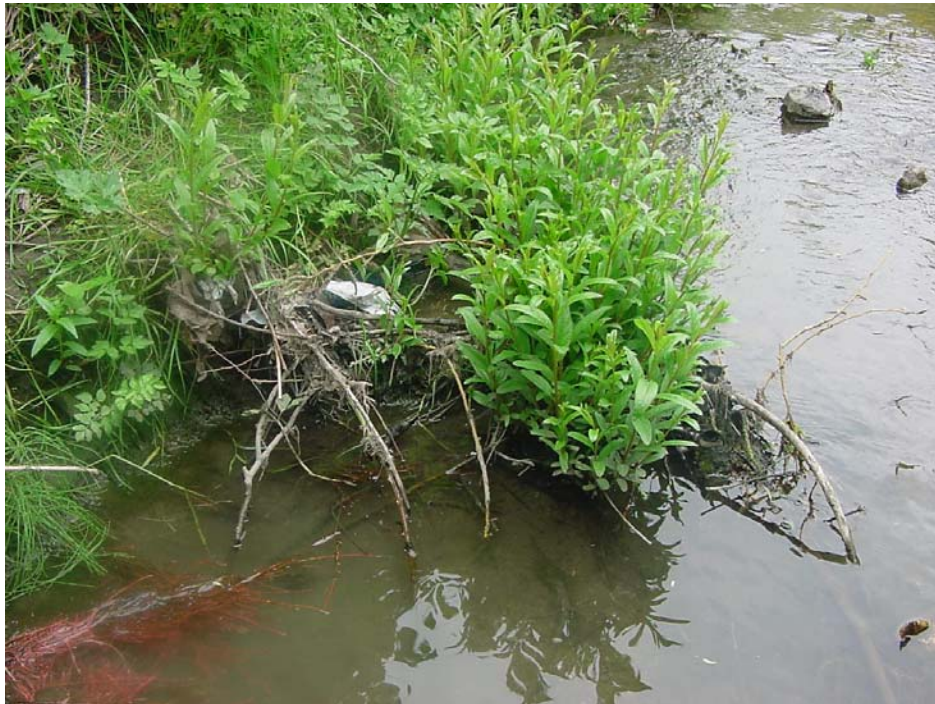
Figure 4: Golden Willow Shoots in Stream

Networks of Golden Willow roots encroach into the active channel, collecting debris and impeding the drainage of storm water (Figure 4). These networks can displace the natural channel bed and its dependent invertebrate populations. During storm events and high flows, there is potential for root networks to be pulled from the bed and block culverts. Willows are also responsible for significant removal of stream water during periods of low flow due to their high rates of transpiration. Finally, Golden Willow out-competes native willows as well as other native species (Crowther, 2000).

- i) Remove the Golden Willow by cutting the tree, leaving a stump half of a metre to one metre in height. Make vertical cuts in the top of the freshly cut stump. This will leave the tree vulnerable to pathogens. Continue to make vertical cuts every two months for about six months, or until the tree dies from stress. The root systems are left intact to ensure bank stability while newly planted native vegetation becomes established (Dept. of Land & Water Conservation, 2002).
