Applies To: 1997 Prelude – Thru VIN JHMBB6...VC007448

## Rattle From the Rear Headliner Area

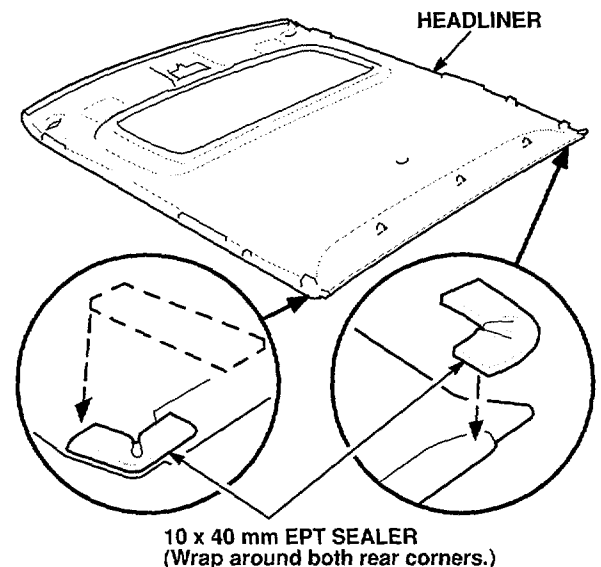
046799

1. Remove the following parts (refer to section 20 of the Service Manual):
  - Door trim (see page 20-41).
  - Passenger grab handle (see page 20-41).
  - Moonroof socket plug and moonroof trim (see page 20-43).
  - Front seat belt upper anchors (see page 24-3).
2. Pull down the following parts, but do not remove them completely:
  - Rear pillar trim pieces (see page 20-41).
  - Front pillar trim pieces (see page 20-41).
  - The rear and the sides of the headliner (see page 20-43).
3. Cut two 10 x 40 mm pieces of EPT Sealer 3T, and wrap them around the rear corners of the headliner.

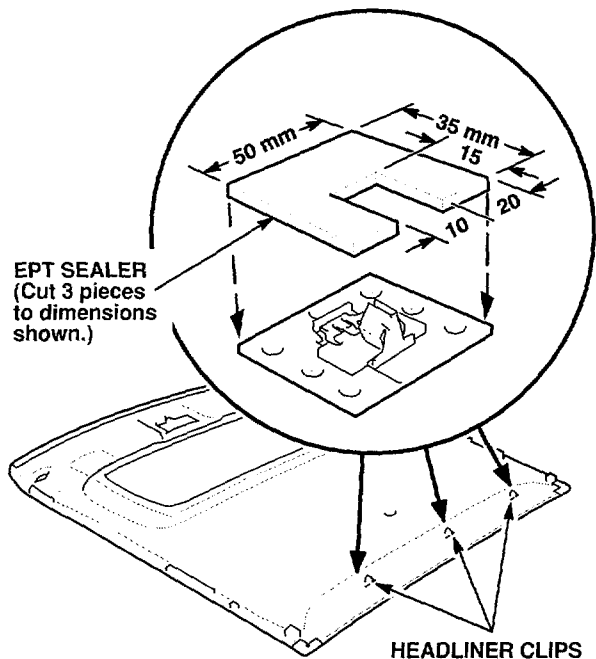
- Cut three U-shaped pieces of EPT Sealer 5T.

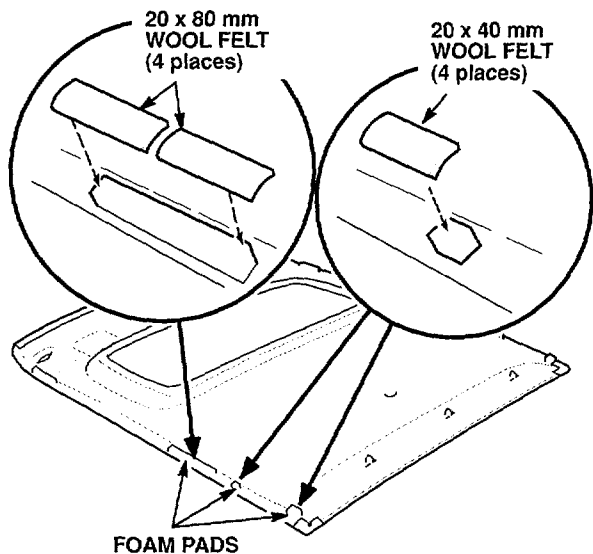
- Wrap the U-shaped pieces around each rear headliner clip.
- Cut four 20 x 40 mm and four 20 x 80 mm pieces of wool felt. Adhere them to the foam pads on both sides of the headliner.

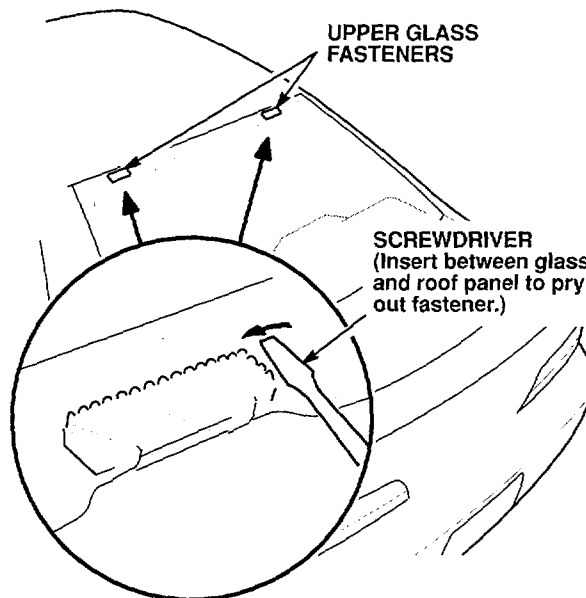
- With a small flat-tip screwdriver, gently pry the two upper glass fasteners from the rear window and the roof panel, and discard them.

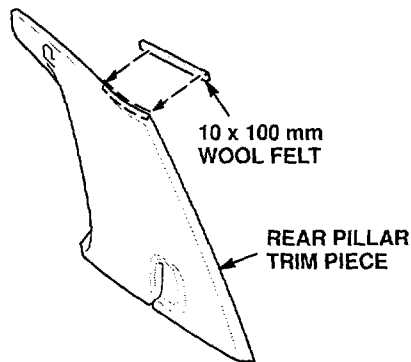
- Cut two 10 x 100 mm pieces of wool felt, and adhere them to the edge of each rear pillar trim piece where it shows signs of contact with the headliner.

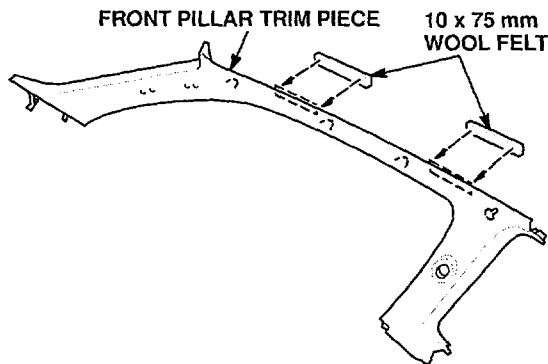
- Cut four 10 x 75 mm pieces of wool felt, and adhere them to the inner edge of each front pillar trim piece where it shows signs of contact with the headliner.
