Applies To: 1997 Prelude – ALL

Whistle From Windshield

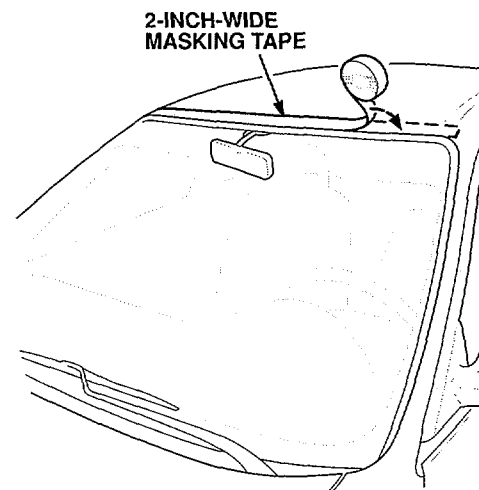
1. To protect the roof, apply masking tape (at least 2 inches wide) along the edge of the entire upper windshield molding.

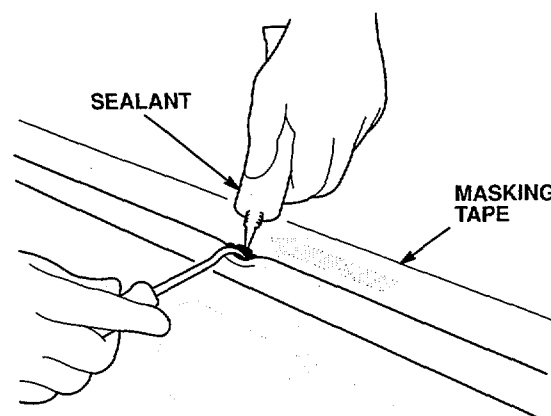
2. Pull up the upper windshield molding using an O-ring pick or similar tool, and apply 3M Black Super Silicone Sealant under the entire molding.

3. Press the rubber molding to smooth it out and make sure it sits flush.
4. Allow the sealant to set for about 5 minutes. Remove the masking tape, and clean up any excess silicone with 3M General Purpose Adhesive Cleaner.
