Applies To: **1997 – 98 Prelude – ALL**
1999 Prelude – thru VIN JHMBB6...XC010811

Door Is Difficult to Open From the Inside (Supersedes 97-052, dated August 27, 1997)

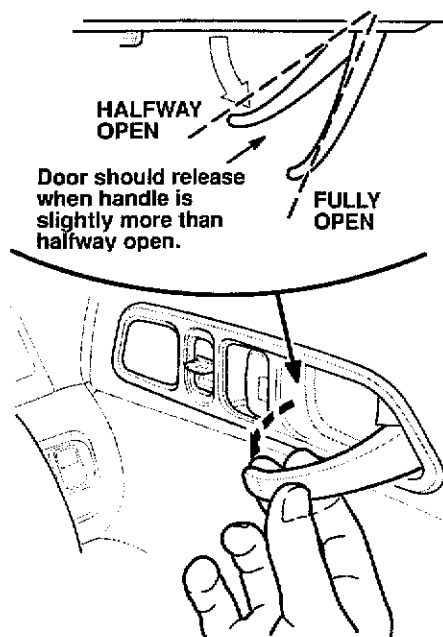
Visually check how far you have to pull out the inside door handle before the door releases.

- If the door releases with the door handle pulled out slightly more than halfway, there is no need to replace the inner handle rod. Go to step 7 of REPAIR PROCEDURE.
- If you have to pull the door handle out almost to the fully open position to release the door, replace the inner handle rod. Go to step 1 of REPAIR PROCEDURE.

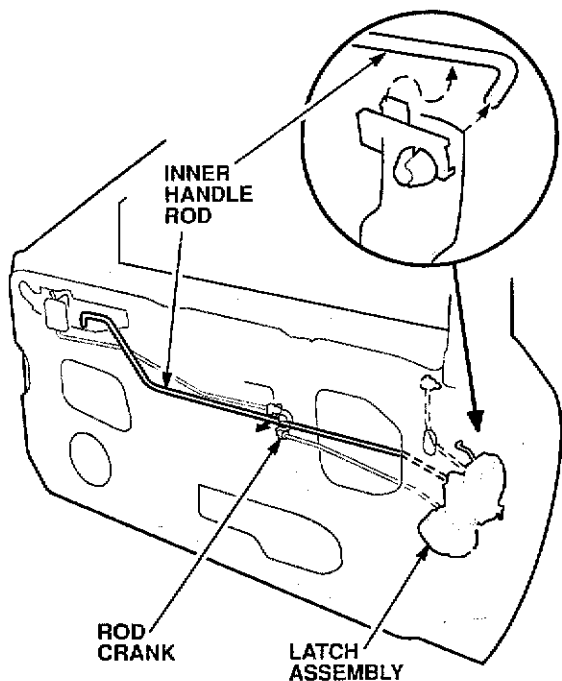
1. Remove the door panel. Refer to page 20-4 of the 1997 - 99 Prelude Service Manual.
2. Remove the plastic rain protector by cutting the adhesive with a razor blade.
3. Disconnect the inner handle rod from the rod crank and the latch assembly. Remove the rod from the door.

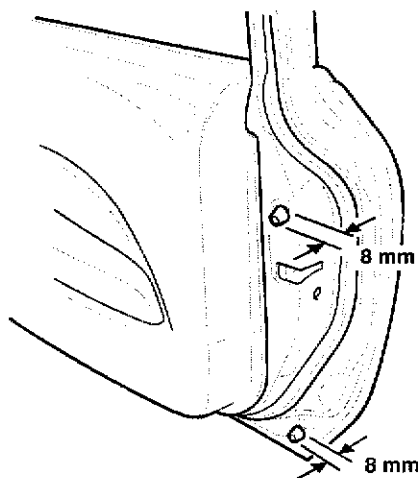
4. Install the new inner handle rod to the latch assembly and the rod crank.
5. Reinstall the plastic rain protector.
6. Reinstall the door panel.
7. Adjust both door cushions to 8 mm.

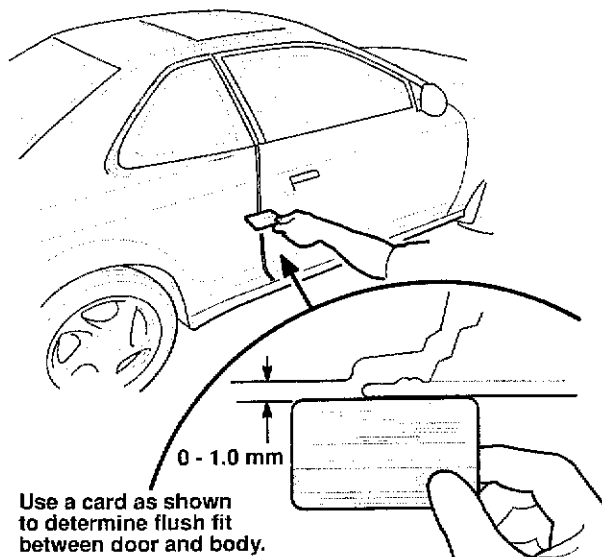
8. Use a credit card or driver's license to inspect the fit at the rear of both doors. The door edge should be flush with the body to 1.0 mm away from the body.

9. If the door edge is recessed or if there is a gap of more than 1.0 mm, adjust the striker.
10. Clean the latch with shop air to remove any dirt.
11. Use a pocket screwdriver to apply a small amount of Lithium dielectric grease to the lower slide. Use the screwdriver to close the latch to the first click, then apply a small amount of grease to the upper slide.
